BENNINGTON LANDFILL

Houghton Lane  
Bennington Vermont

Potential Hazardous Waste Site  
Preliminary Assessment

January 1986

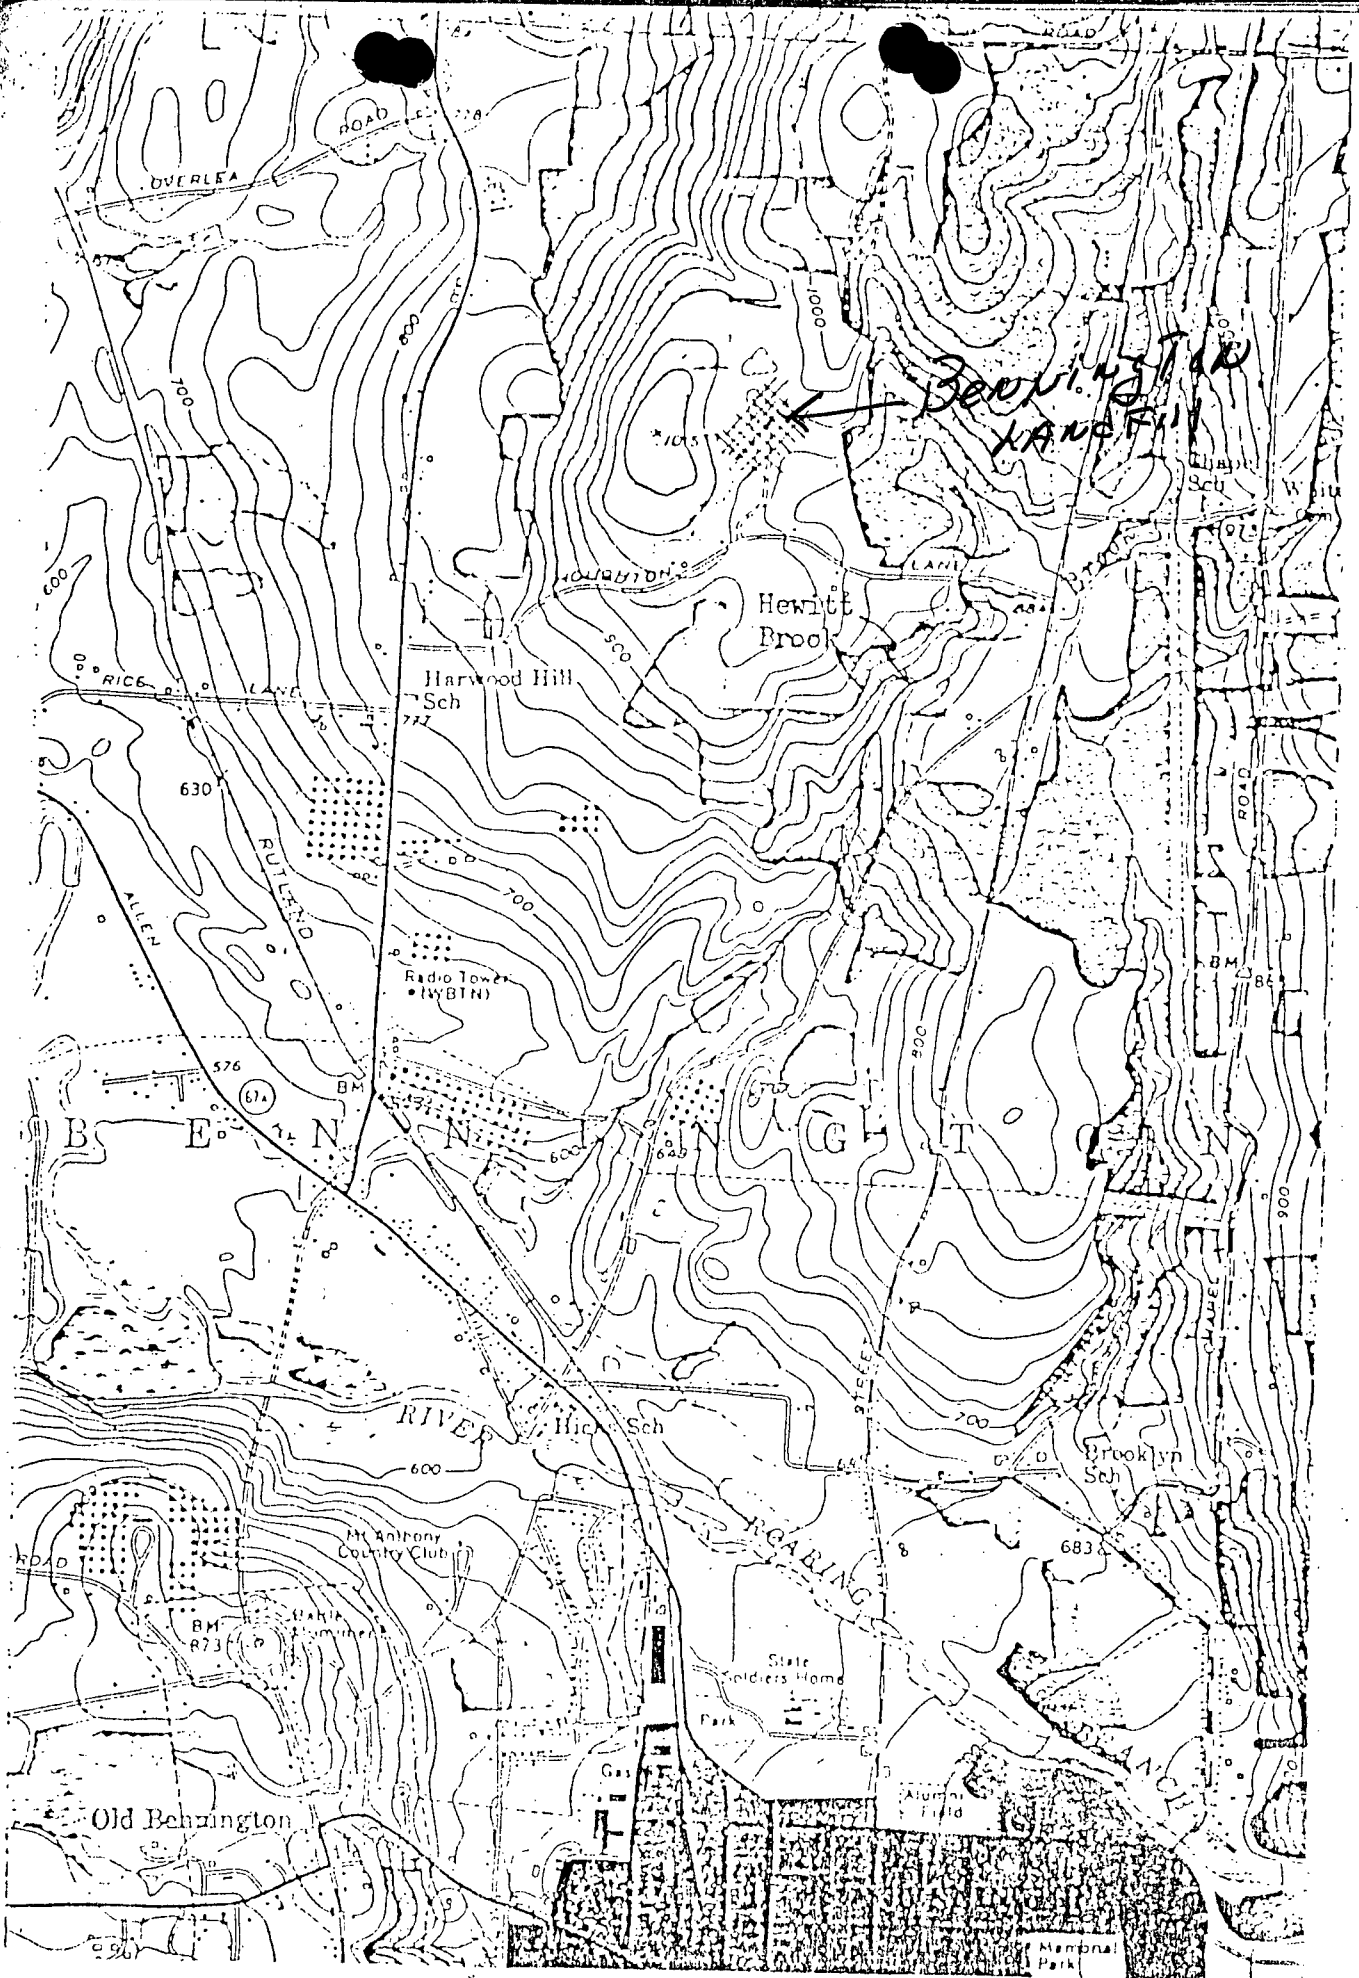
Figure 2: Landfill(cross-hatched area) and Hewitt Brook.
